Manhole Inspection Summary

Manhole # S55M__016MH

Insp Date: **12/30/08 2:39 PM**

Location Address: **3600 odonnell st**

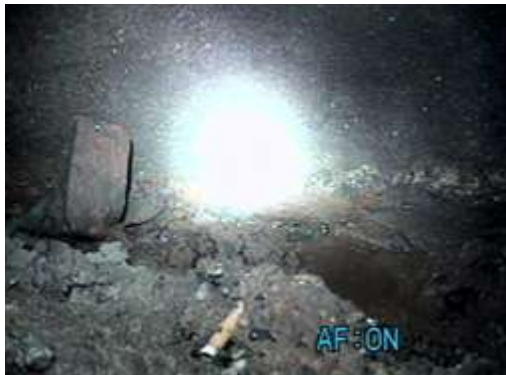
Defect 3

Condition: ☐ Sound ☐ Cracked ☐ Root Intrusion ☐ Deteriorated ☐ Leaks ☒ **Debris**

channel debris

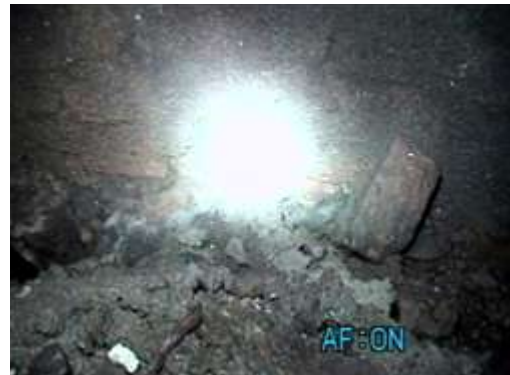
Defect 2

Condition: ☐ Sound ☐ Cracked ☐ Root Intrusion ☐ Deteriorated ☐ Leaks ☒ **Debris**

bench debris

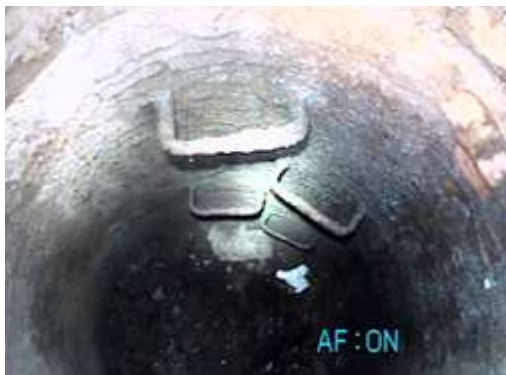
Defect 1

Steps Count: **4** Missing: **0** ☒ **Corroded**

steps corroded

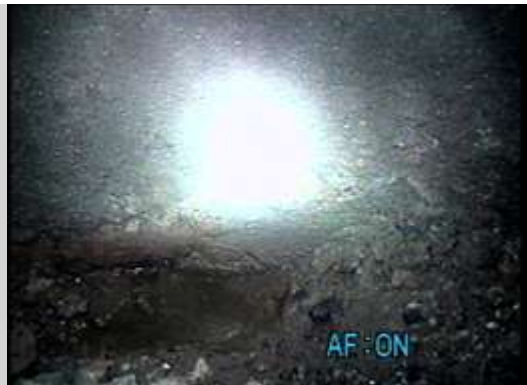
3 O'Clock Inflow

8 in. Circular Gravity Sewer
Pipe In @ 3 O'Clock

Deposits: ☐ None ☐ Mud ☐ Sludge ☒ **Debris** ☐ Grease

Silt Depth: 8 (in.) Deposits Extent: **Heavy**
